# **CYCLIC AND LOW TEMPERATURE EFFECTS ON MICROCIRCUITS**

## **FINAL TECHNICAL REPORT**

**AUGUST 1975 — AUGUST 1977**

**MCDONNELL DOUGLAS ASTRONAUTICS COMPANY - EAST**

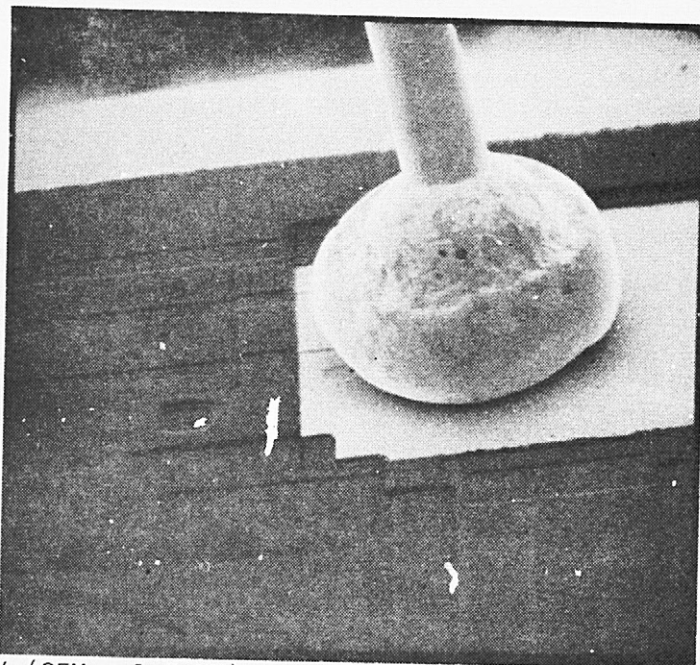
S/N 661

FIGURE A3. WIRE BOND AT THE DIE

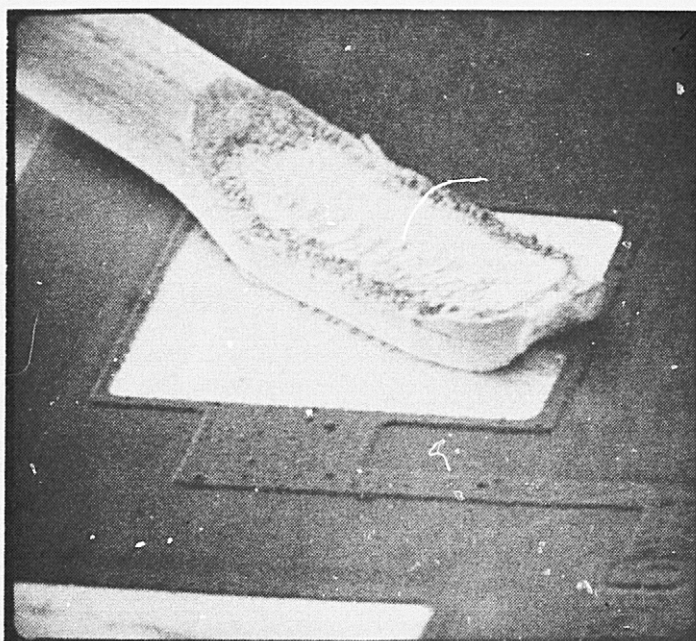
S/N 695

FIGURE A12. WIRE BOND AT THE DIE

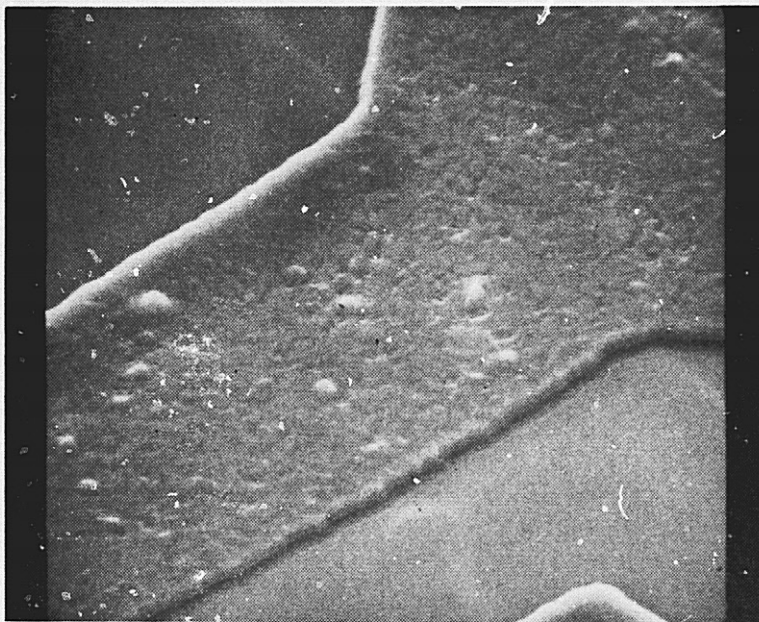
S/N 695

FIGURE A22. SEM VIEW OF Vcc STRIPE  
AFTER GLASSIVATION REMOVAL.

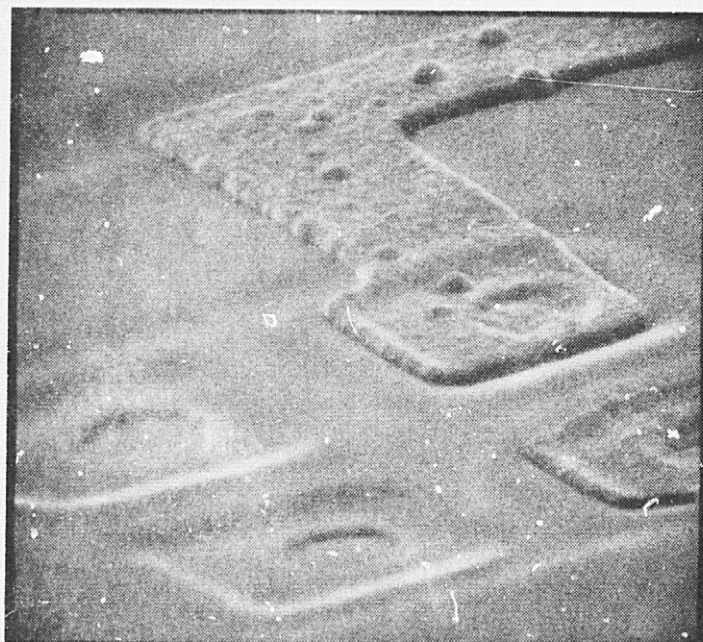
S/N 695

FIGURE A25. EXAMPLE OF GRAIN GROWTH (BUMPS) AND STEP COVERAGE (PRIOR TO GLASSIVATION REMOVAL).

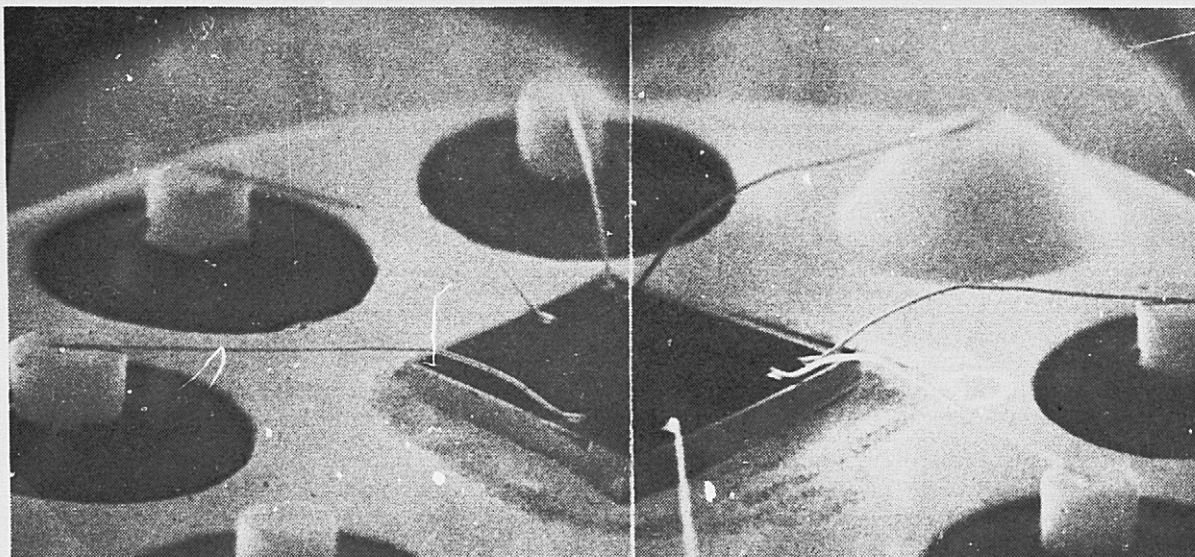
S/N 685

FIGURE A30. COMPOSITE SEM PHOTO OF THE LEAD WIRE DRESS. THE KINKS IN THE WIRES AT MID SPAN INDICATE THAT THEY PROBABLY HAD BEEN PULL TESTED.

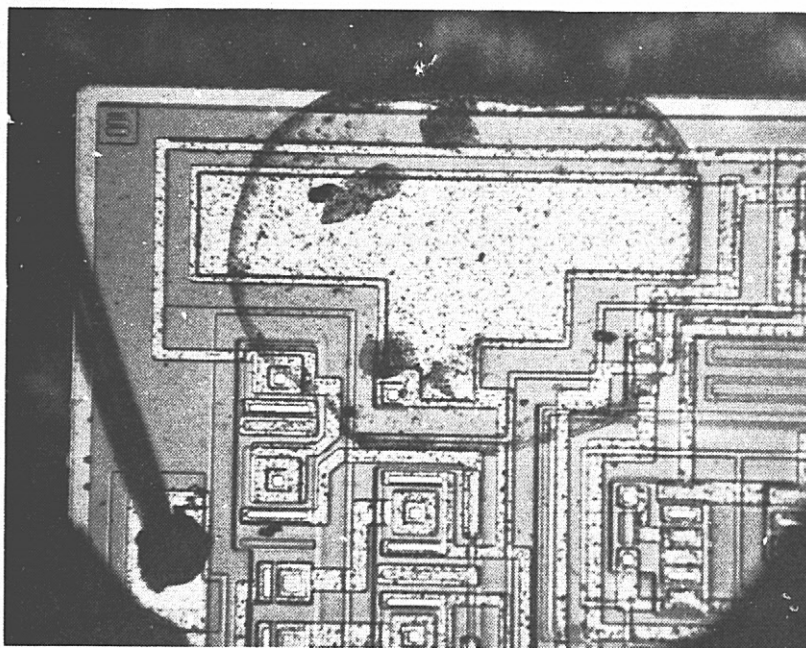
S/N 611

FIGURE A52. LARGE STAIN OVER THE MOS CAPACITOR

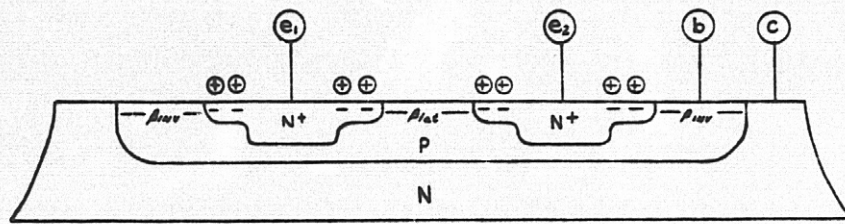
Curve tracer tests of the parts that were failed at room temperature established that the high input currents were due to inter-emitter transistor action. The excessive  $I_{IH}$  saturated with increasing input voltage (channeled characteristic) and  $I_{IH}$  was excessive only with bias applied to  $V_{CC}$  (with  $V_{CC}$  open, the input leakage was negligible). This meant that the lateral parasitic (NPN)  $h_{FE}$  between the emitter diffusions of the TTL input transistor (Q1) had increased during stress. The failures were bake recoverable (see column IV of Table B2 for post bake mean values) indicative of a surface instability mechanism. Therefore, the  $h_{FE}$  increase was attributed to inversion of the p-type base region around the  $n+$  input emitters due to the accumulation, from drift of mobile ions, of a net positive charge in or over a passivation layer above the base as illustrated in Figure B1. The inverted region effectively increased the size of the emitters which narrows the inter-emitter spacing (lateral base widths) causing  $h_{FE}$  to increase.

FIGURE B1. DIFFUSION PROFILE OF INPUT TRANSISTOR SHOWING  
INVERTED BASE REGION OF LATERAL NPN TRANSISTOR

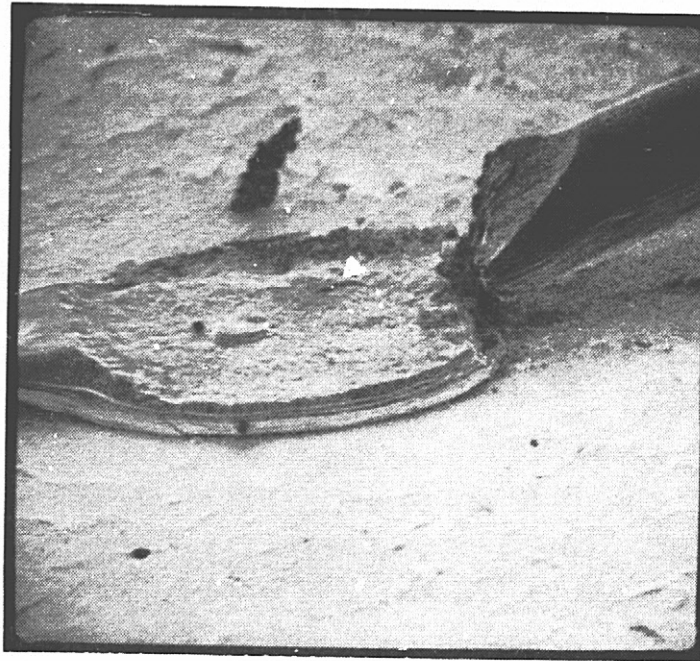
BROKEN WIRE BONDS - Two (2) parts failed due to an open pin at the 25°C and -55°C measurement temperatures. The opens were traced to a broken Al-Au ultrasonic wire bond at the lead frame. Each failure was due to brittle fracture of the heel as illustrated in Figure B3. Examination of the other bonds in the package disclosed that several were on the verge of failure as illustrated in Figures B4 and B5. Removal of the bond feet by dissolving the aluminum in sodium hydroxide revealed that the lead frames were covered with gold-rich intermetallic growth under each foot, as illustrated in Figure B6. Further investigation (discussed in the post-life evaluation section) established that the intermetallics were generated during device processing or preconditioning. These findings indicate that because of the existing brittle intermetallics the bonds were susceptible to flexure fatigue at the heel and broke as the wires flexed during temperature cycling.

FIGURE B3. SEM PHOTO OF AN OPEN LEAD FRAME WIRE BOND AT PIN 7

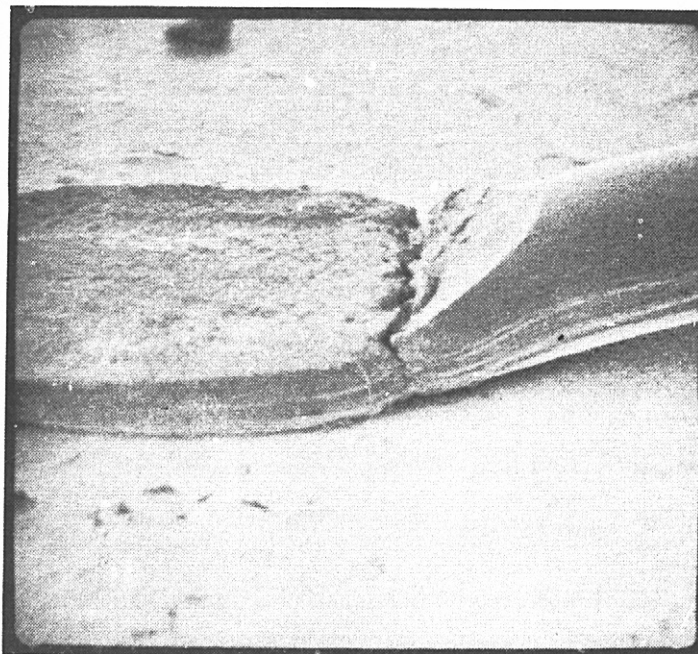
FIGURE B4. SEM PHOTO OF A CRACKED WIRE BOND AT PIN 1.

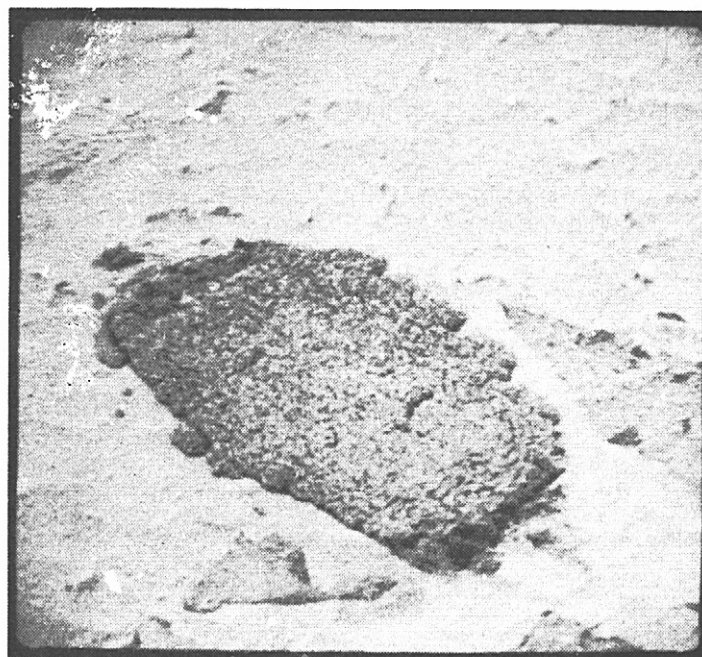
S/N 24

FIGURE B6. INTERMETALLICS ON THE PIN 12 LEAD FRAME  
REVEALED BY DISSOLVING THE BOND FOOT.

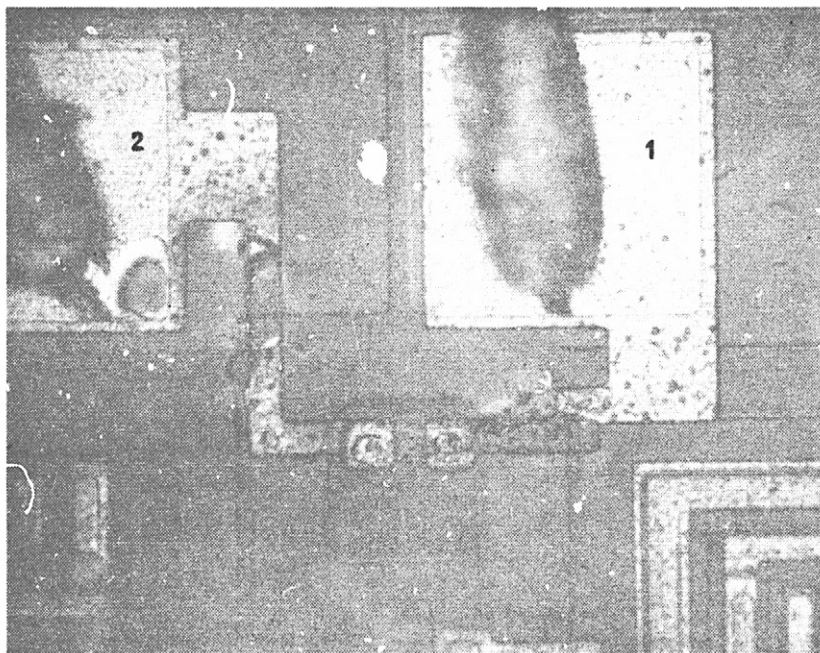
ELECTRICAL OVERSTRESS - Six (6) parts failed catastrophically at all three measurement temperatures due to shorted and open inputs. Each part contained melted open input stripes and flashover shorts between the input emitter diffusions as illustrated in Figure B8. The damage indicated that the inputs were electrically overstressed by an inadvertent differential overvoltage generated across each input pair. Subsequent investigations disclosed that the overvoltage was caused by short-circuits between conductors on the power supply program cards. This is the same problem that had caused the overstress of the Texas Instruments 54L00s and is discussed in detail in the analysis report of that device.

FIGURE B8. EXAMPLE OF TYPICAL DAMAGE SUSTAINED BY AN INPUT PAIR

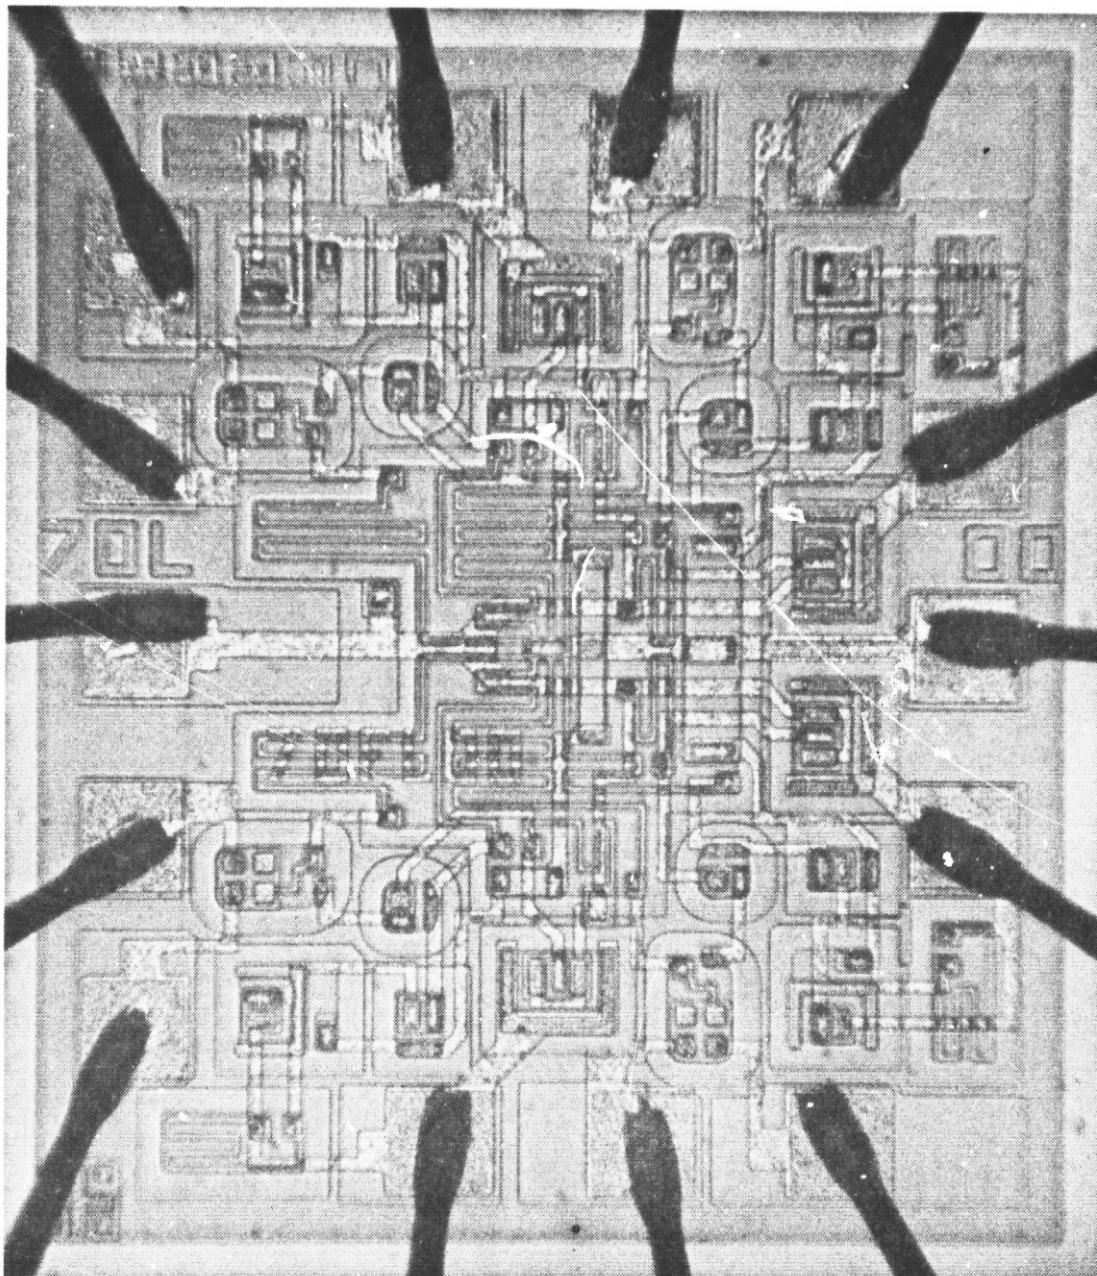
182X (ORIGINAL) S/N 632, GROUP VI  
FIGURE C4. DIE PHOTO SHOWING THE TYPICAL CONDITION OF THE GLASSIVATION AFTER THE TESTS.

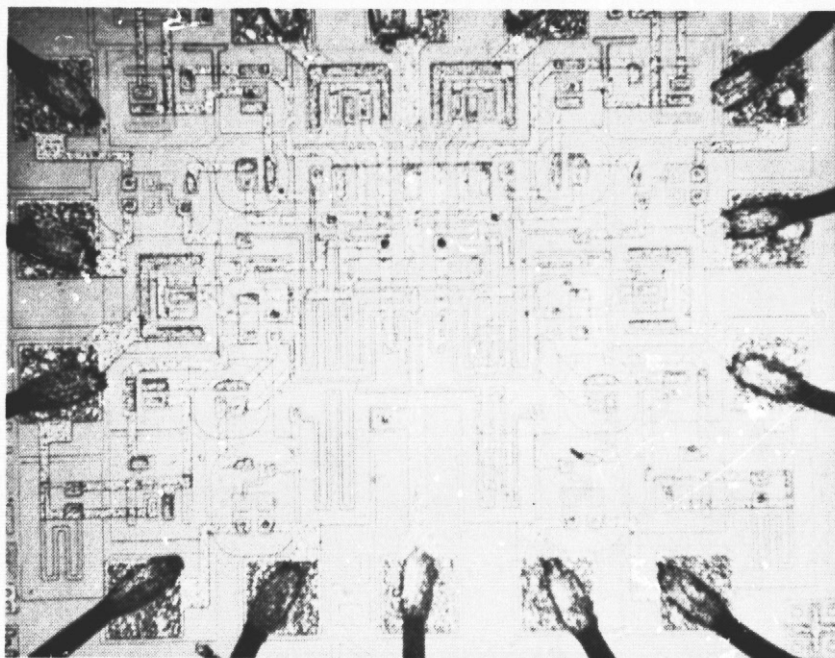
FIGURE C11. EXAMPLE OF ALUMINUM RECONSTRUCTION AT BOND PADS.

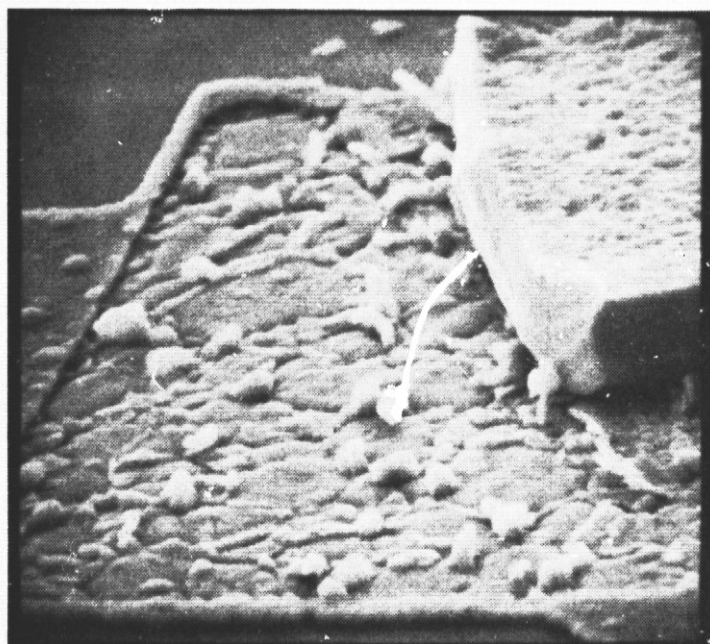
FIGURE C12. SEM PHOTO OF GRAIN BOUNDARY AND HILL FORMATIONS ON THE BOND PADS.

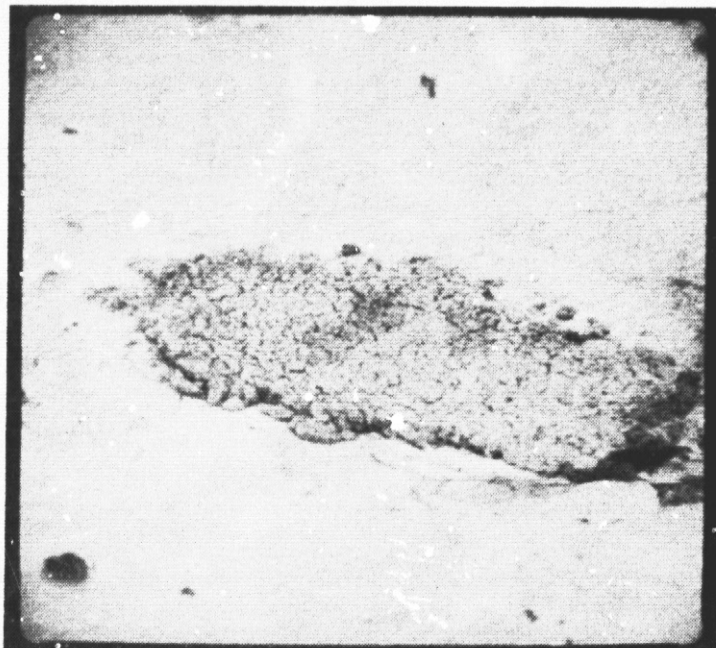
S/N 124, GROUP III

FIGURE C14. INTERMETALLIC GROWTH UNDER THE FOOT OF THE BOND SHOWN IN FIGURE C13

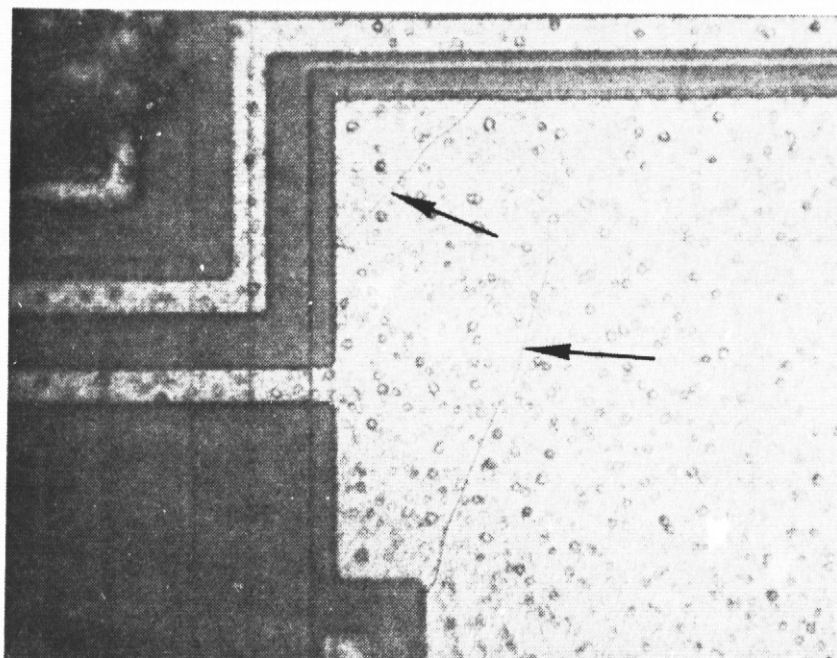
S/N 274, GROUP III

FIGURE C16. CRACKS IN THE GLASSIVATION OVER THE MOS CAPACITOR OF THE GROUP III PART.

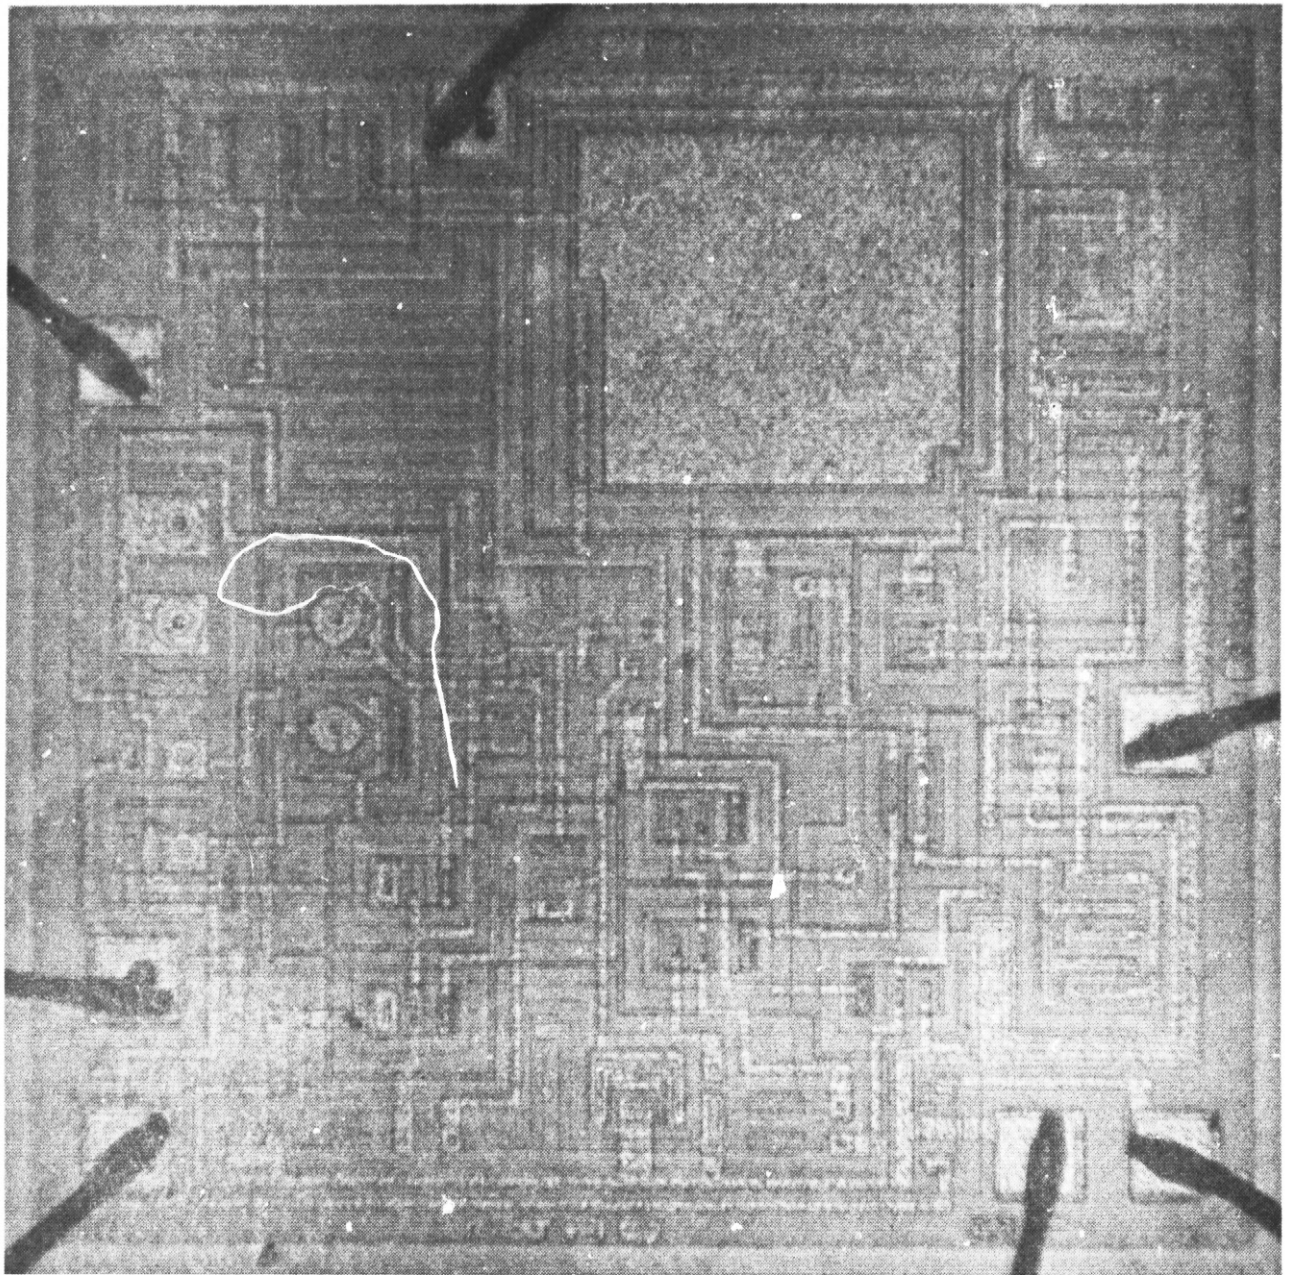
S/N 491, GROUP V

FIGURE C17. PHOTO OF A DIE WHICH ILLUSTRATES THE CONDITION OF THE GLASSIVATION,  
TYPICAL OF GROUP I, II, IV, V AND VI PARTS.

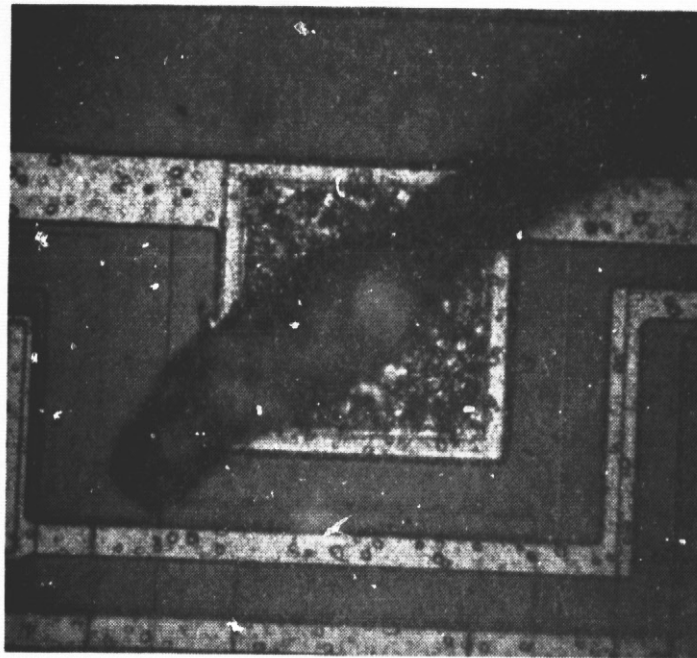
FIGURE C20. EXAMPLE OF ALUMINUM RECONSTRUCTION AT THE  
BOND PAD (PIN 7).

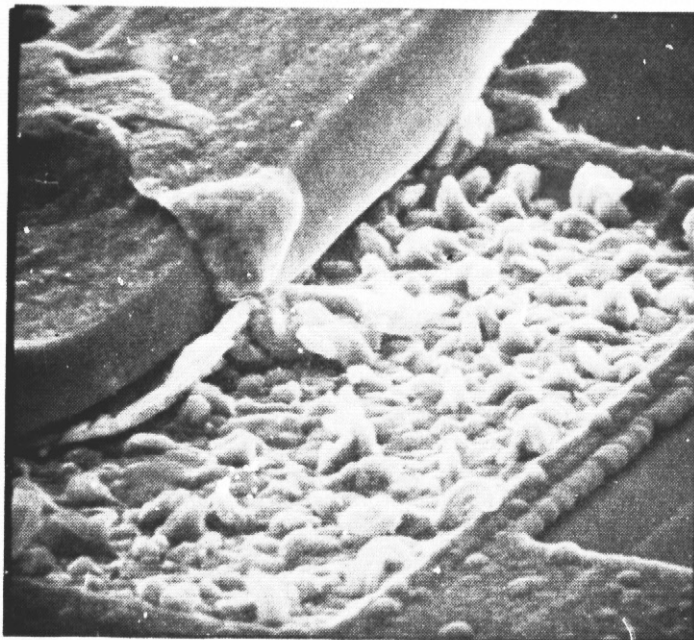
FIGURE C21. SEM PHOTO OF ALUMINUM RECONSTRUCTION AT  
THE BOND PAD (PIN 4).

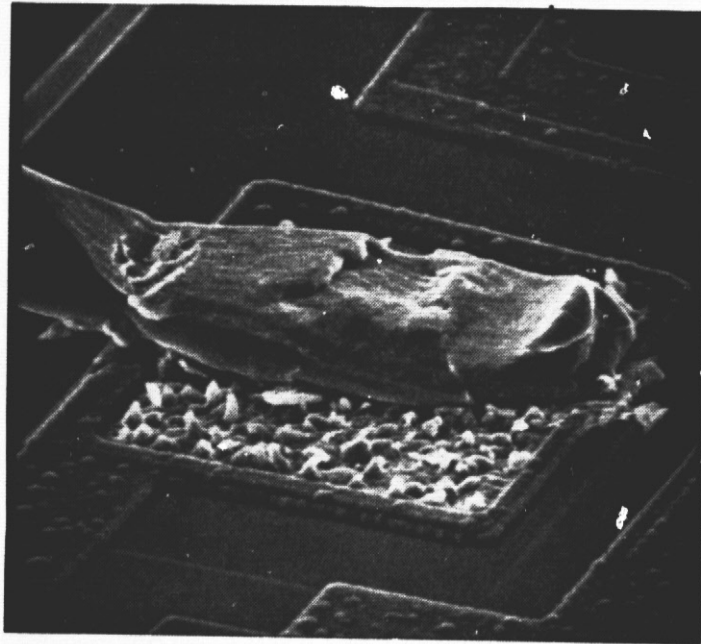
FIGURE C24. DEGRADED BOND AT PIN 6.

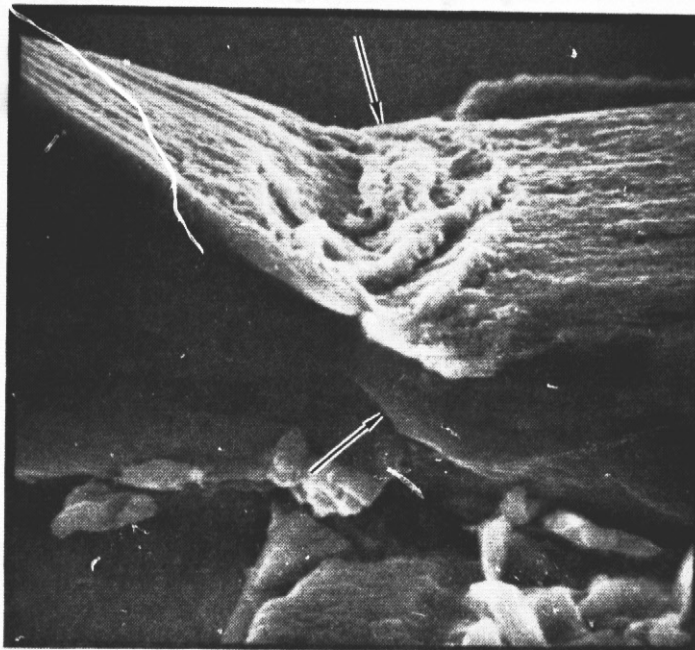
FIGURE C25. CLOSE-UP OF THE HEEL OF THE PIN 6 BOND  
SHOWING THE TEAR AND WRINKLE (ARROWS).

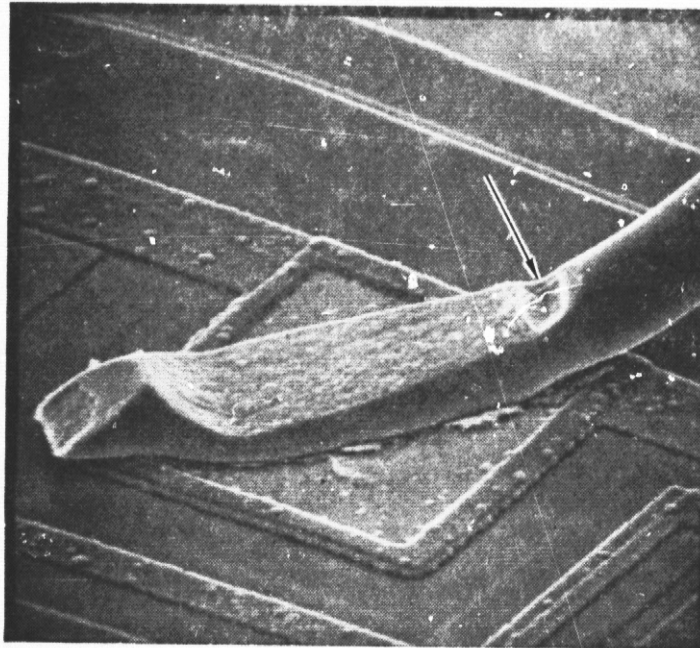
FIGURE C26. WORST CASE EXAMPLE OF A TEAR AT THE HEEL (ARROW) FOUND IN THE UNSTRESSED SAMPLE (PIN 7).

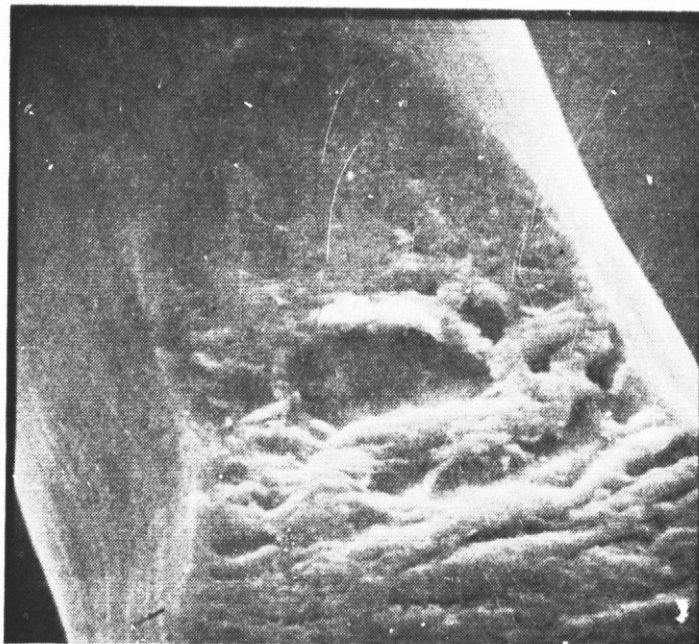
FIGURE C27. CLOSE-UP OF A TYPICAL TEAR AT THE HEEL OF A BOND IN THE UNSTRESSED SAMPLE.

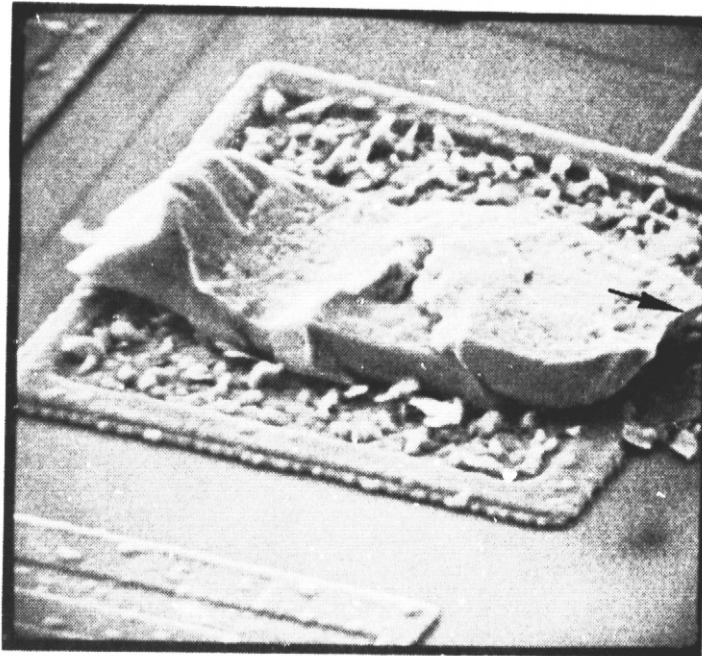
FIGURE C28. EXAMPLE OF FAILED BOND (PIN 6) SHOWING THE LOCATION OF THE BREAK (ARROW).

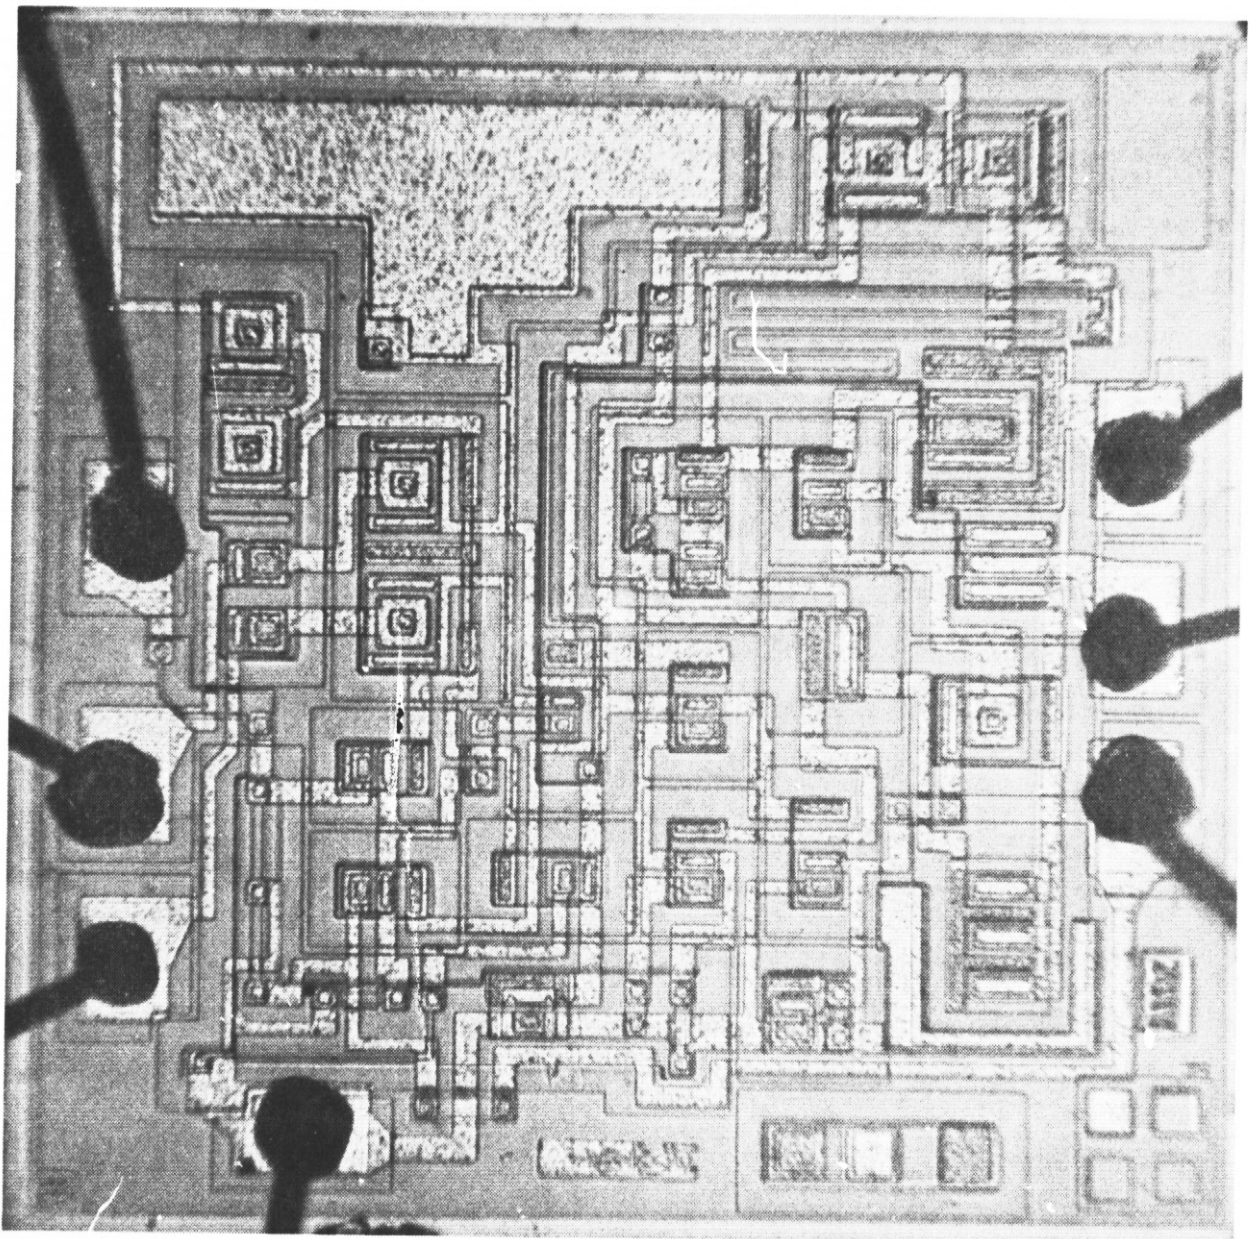
S/N 504, GROUP VI

FIGURE C30. PHOTO OF A DIE WHICH ILLUSTRATES THE CONDITION OF THE GLASSIVATION  
TYPICAL OF ALL SIX TEST GROUPS.

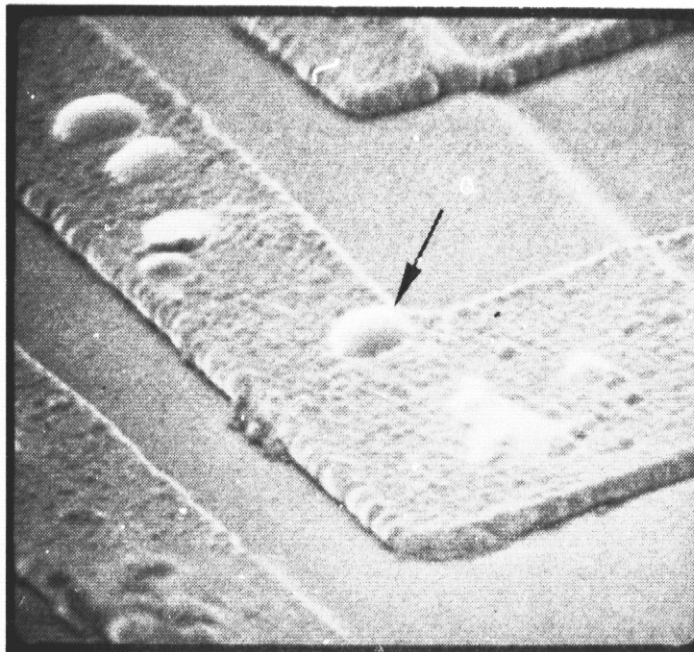
S/N 241, GROUP III

- C. DIE SURFACE: None of the parts showed any sign of degradation of the glassivation as a result of the tests. A photograph of a typical die is presented in Figure C30. The test Group II and III parts contained a noteworthy anomaly which was not related to the test condition. The surface of the glassivation of each part contained drops of contamination above the stripes, as shown in Figure C31. The droplets would swell up and burst when examined at high magnification in the SEM as illustrated by the sequence shown in Figures C32 through C34. The contaminant more than likely was introduced during manufacturing and, since the material did not result in any degradation or failure of a part, no attempt was made to identify its composition or source.

FIGURE C32. SEM CLOSE UP OF THE DROPLETS SHOWING THE INITIAL SHAPE OF THE DROPLET (ARROW) TO BE INVESTIGATED.

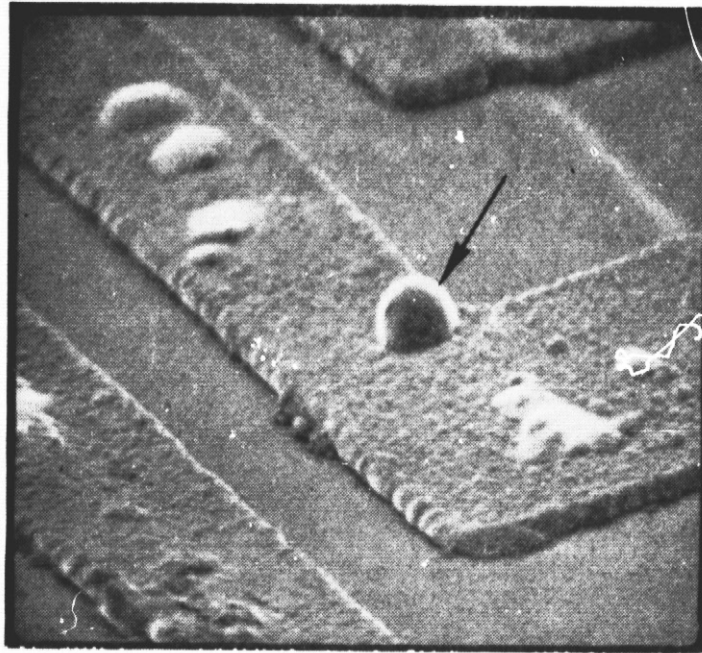
S/N 241, GROUP III

FIGURE C33. SEM PHOTO SHOWING THE SWELLING INDUCED IN ONE DROPLET (ARROW) AFTER EXAMINING IT AT HIGHER MAGNIFICATIONS.

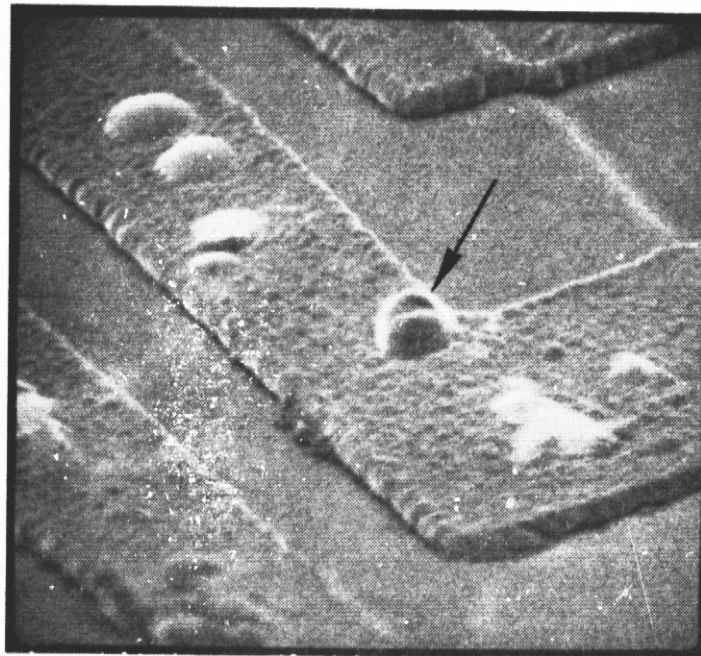
S/N 241, GROUP III

FIGURE C34. SEM PHOTO TAKEN A FEW SECONDS AFTER FIGURE C33 WAS TAKEN SHOWING THAT THE SWOLLEN DROPLET (ARROW) HAS COLLAPSED.

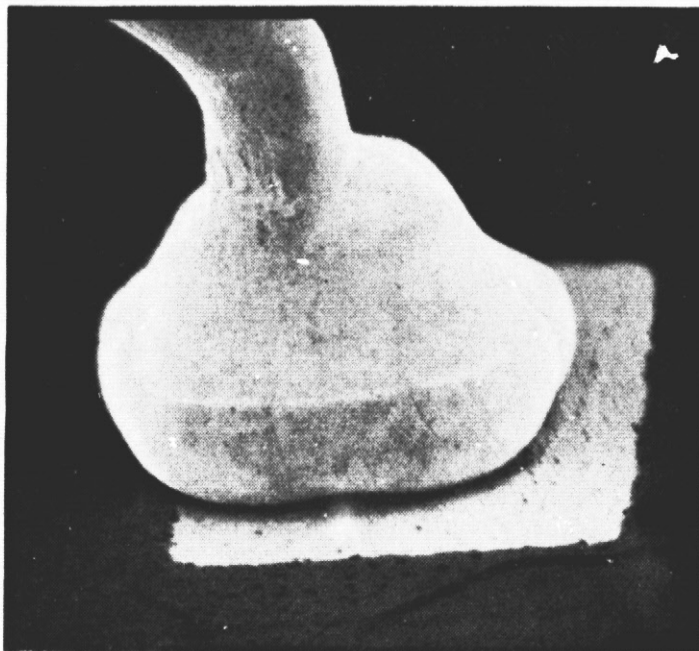
S/N 481, GROUP V

- D. WIRE BONDS: The wire bonds in five of the parts showed no sign of degradation as a result of the test conditions. A typical bond at the die and at the post are shown in Figures C35 and C36. The Group IV (125°C Life) part contained some intermetallic growth around most of the Au-Al bonds at the die as illustrated in Figure C37.

FIGURE C35. WIRE BOND AT THE DIE.

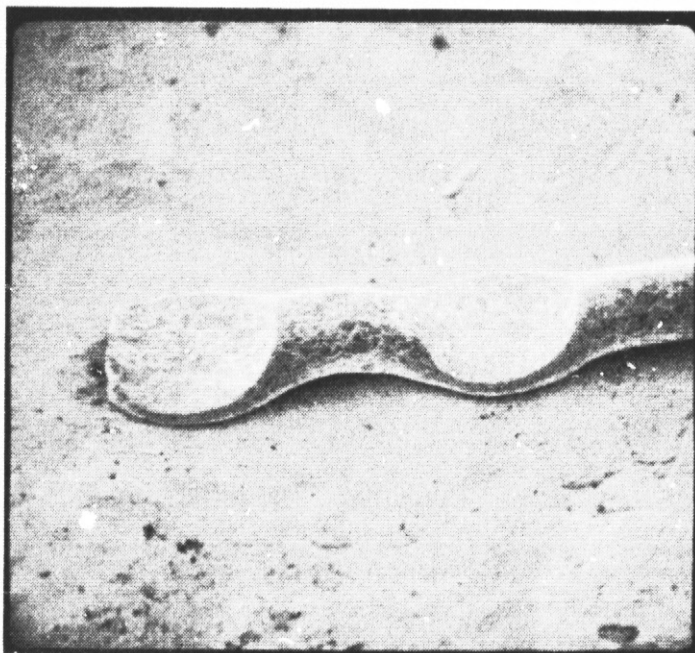
S/N 481, GROUP V

FIGURE C36. WIRE BOND AT THE POST.

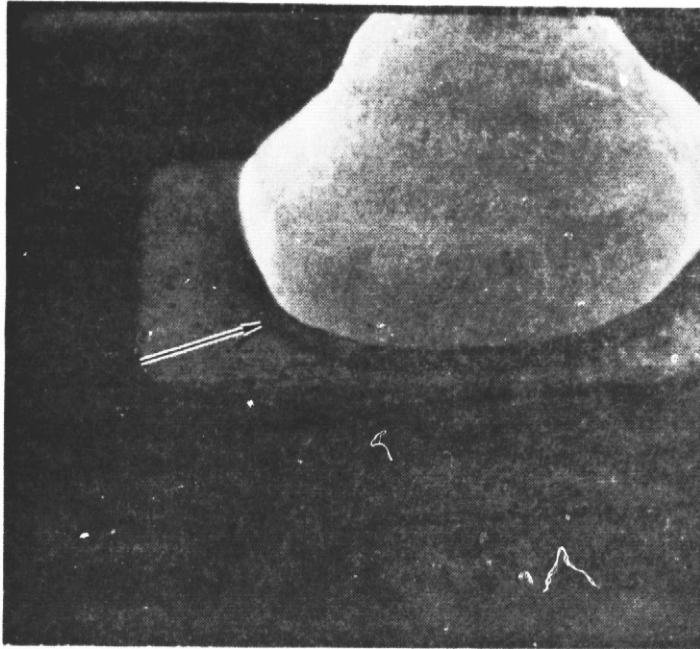
S/N 362, GROUP IV

FIGURE C37. PIN 8 BOND SHOWING RING OF INTERMETALLICS (ARROW).

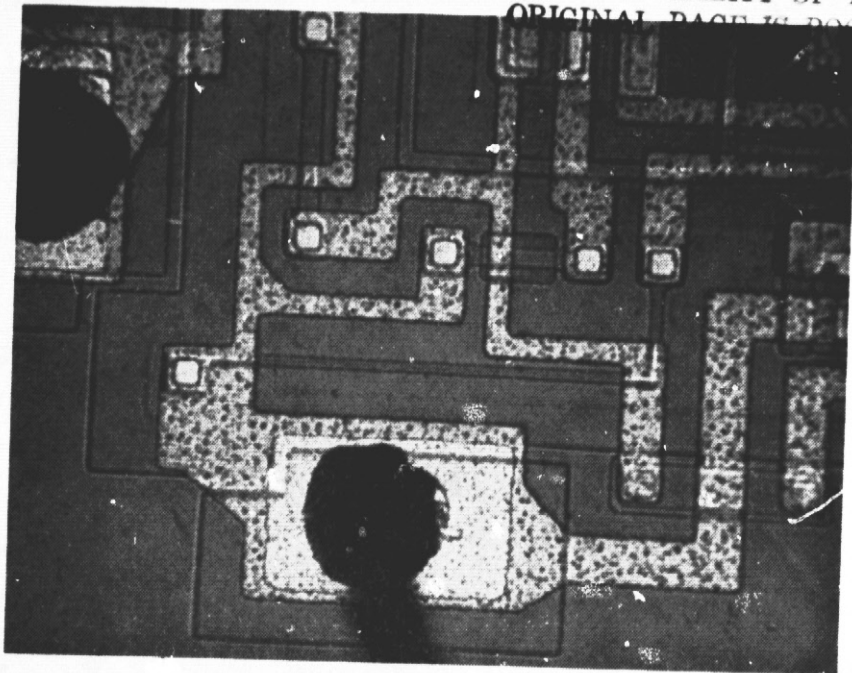
S/N 362, GROUP VI

- E. METALLIZATION: The metallization of the three life test parts (Groups IV-VI) was unaffected by the test conditions. Typical post life condition of these three parts is shown in Figures C38 and C39. The metallization of all three Group I, II, and III parts showed evidence of mild aluminum reconstruction as a result of the temperature cycling. Under optical examination the unglassivated aluminum at every bond pad appeared darkened due to roughening as illustrated in Figure C40. Under SEM examination grain boundary formations and fatigue striations were evident as illustrated in Figure C41. The aluminum beneath the glassivation was also restructured as illustrated in Figure C42 but not as severely as was the unglassivated aluminum. Aluminum reconstruction can result in increased sheet resistivity and can promote electromigration. However, the results of the

FIGURE C39. V- (PIN 4) METALLIZATION

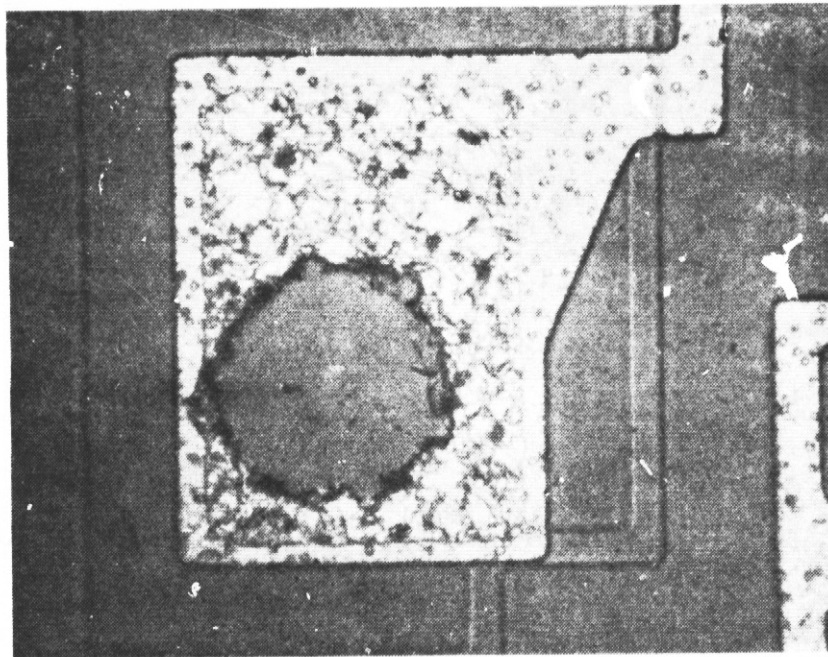
S/N 223, GROUP III

FIGURE C45. EXAMPLE OF VOID FAILURE DUE TO SEPARATION OF THE ALUMINUM FROM THE  $\text{SiO}_2$  (PIN 1).

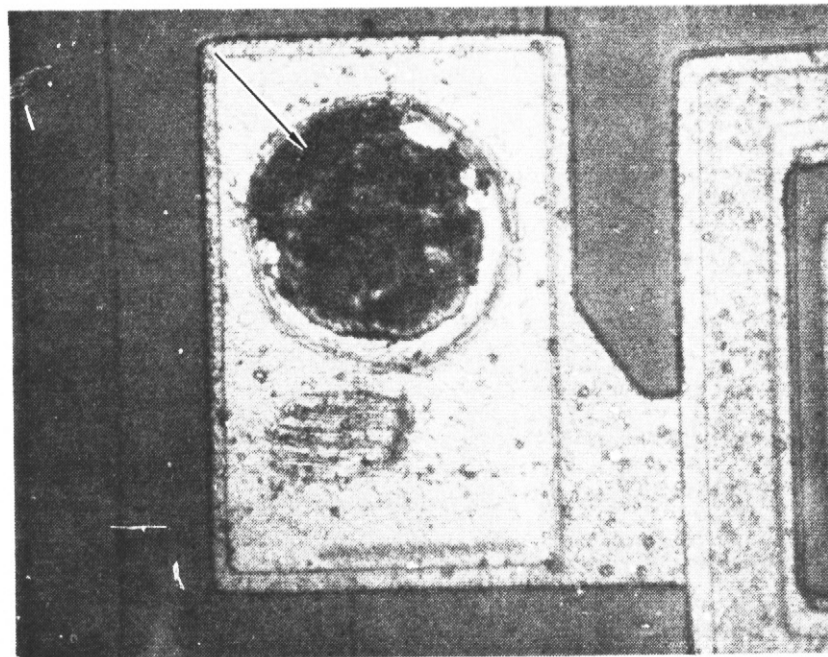
S/N 335, GROUP IV

as shown in Figure C45. The two failures were probably due to poor adhesion of the aluminum to the  $\text{SiO}_2$ . Four bonds separated in the gold-aluminum intermetallic zone. In each instance the pad was covered with a mound of gold colored intermetallics as illustrated in Figure C46. This indicated that the failure was the result of Kirkendall voiding in  $\text{Au}_5\text{Al}_2$ . The other six bonds in each of the four packages exhibited satisfactory pull strengths ranging from 2.9 grams to 6.4 grams (mean = 4.40 grams). This indicates that the excessive intermetallic growth which led to the four bond failures was caused by an isolated bonding error, such as excessive dwell time, rather than by excessive test temperatures. In two instances, the low pull strength was the result of a wire breaking at less than 2 grams. In both cases the wire broke above the ball, contained no deficiency, and was necked down at the break in the same manner as all of the other wires which broke at satisfactory levels as illustrated in Figure C47. Therefore these two breaks were not considered significant. The results of these pull tests indicated that no anomalous condition was induced by the environmental tests. The post-life pull strengths were essentially the same as the pre-life pull strength. However, the results also indicate that the environmental tests in conjunction with periodic electrical testing did not effectively detect weak bonds. Only two parts failed due to open bonds during the environmental tests, yet the pull test revealed seven bonds with zero gram pull strength in parts that had passed all electrical testing. In each case the bond was open and lifted (pin 5 of S/N333) or open and barely contacting the pad. Three of the zero strength bonds involved a  $V_{\text{IO ADJ}}$  pin (pins 1 and 5) and thus could not have been detected electrically (these pins were not tested and were not biased), but four involved  $V+$ ,  $V-$ , or an input or output pin and could have been detected. Temperature cycling and elevated temperature life are needed to accelerate or aggravate to failure any weak or marginal bond, but the pull test results indicate that these tests must be supplemented with a centrifuge or a monitored shock/vibration type of test to detect the weak bond.

FIGURE C46. LIFT-OFF PATTERN OF PIN 7 SHOWING THE MOUND OF INTERMETALLICS (ARROW).

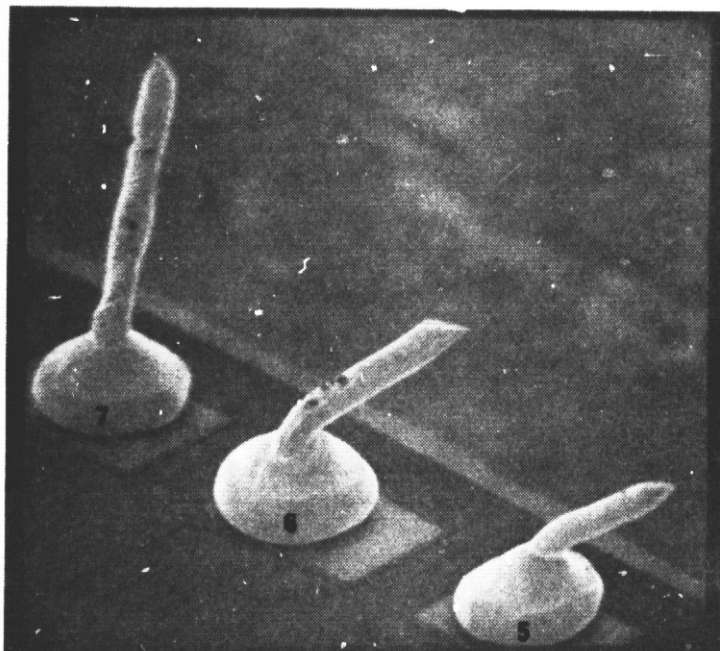
S/N 581, GROUP VI

- C. PULL TESTS: The results of the wire pull tests are presented in Table C11. Seventeen bonds and two wires failed at less than the specified minimum limit of 2.0 grams and these failures are summarized in Table C12. Eleven bonds lifted (separated) from the aluminum pad at the Au/Al interface. Examination of the pad disclosed that in ten instances, the aluminum was compressed under the ball, but the inprint area contained little or no sign of intermetallic formation as illustrated in Figure C43. This indicated that these failures were the result of underbonding, probably caused by insufficient heat or dwell time during the bonding operation or possibly incomplete glassivation removal. This same problem was responsible for three failures during the pre-life pull tests. In one instance, the pad was badly smeared as shown in Figure C44, indicating that this failure was caused primarily by tool slippage during the bonding operation. Two bonds failed due to separation of the bond pad aluminum from the SiO<sub>2</sub> passivation

FIGURE C47. SEM PHOTO OF THE FAILED PIN 6 WIRE (CENTER) WHICH BROKE AT 1.8 GRAMS. THE L/H WIRE BROKE AT 3.8 GRAMS AND THE R/H WIRE BROKE AT 4.4 GRAMS.
